Engine Burn Fracture

Development of Engine Burn Fracture

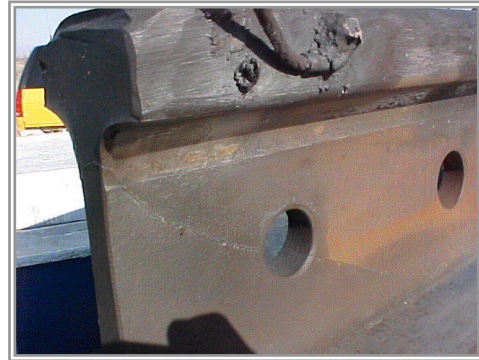
Bolt hole cracks are, of course, not visible until a bolt or the joint bar is removed, unless the defect has progressed above the joint bar and through the railhead or below the bar and through the base.

- After removal of the joint bar the defect may be recognized by a hairline crack extending from the bolt hole for the length of the defect.

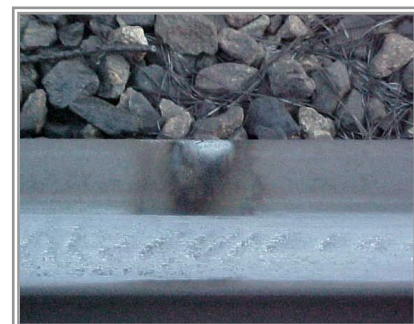
One result of external damage can be a sudden rupture of the rail in the transverse direction.

- It is similar to the ordinary break, except that the break can be attributed to some event that caused it.

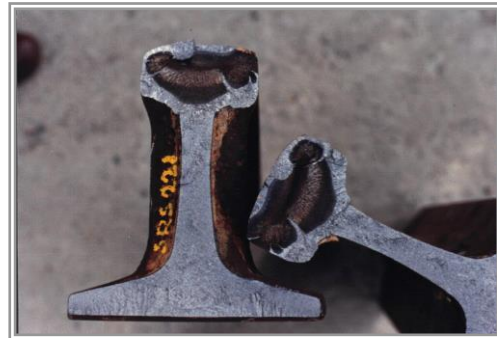
A defective plant weld may be a progressive transverse defect in the railhead within the area where two rails have been joined by a pressure welding process.

Defective plant welds may be caused by slag inclusions, oxide entrapments, improper fusion during the welding process, or thermal cracks that can result from rapid or otherwise improper cooling.
